Against Scale and Rust References / Quality / Studies

Christiani Wassertechnik GmbH

Vulcan – Against Scale and Rust

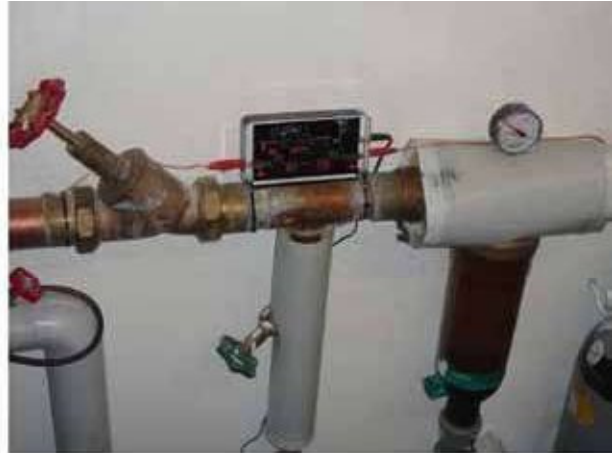
Ice Machine

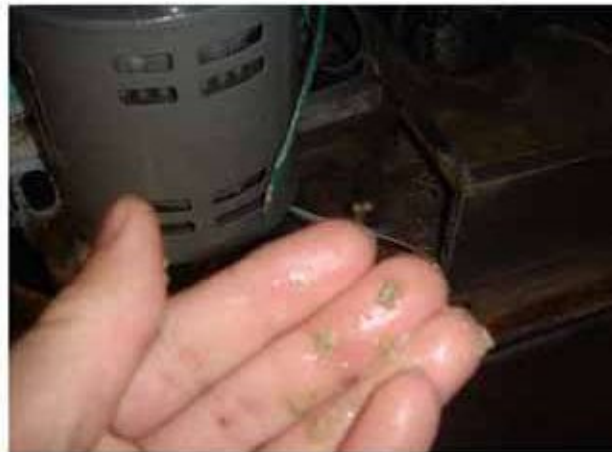
Vulcan 5000

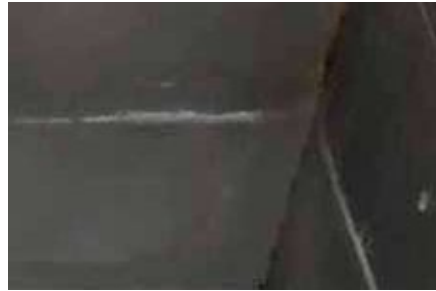
Picture 1: Etched stainless steel after only 3 weeks in service, without using Vulcan.

The R2D2 had been in service only 3 weeks and you can see the stainless steel is already etched at the water line (Picture 1). The water feeding the R2D2 was changed to being fed after the standard 25 micron but before the 5 micron carbon filters.

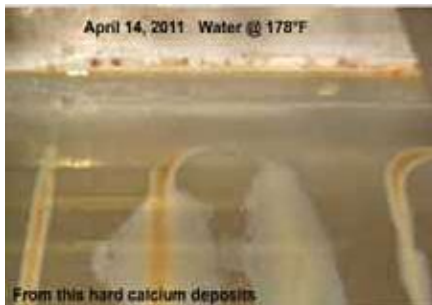
Without Vulcan

Before using Vulcan - April 14, 2011

Hard calcium deposits in the pan.

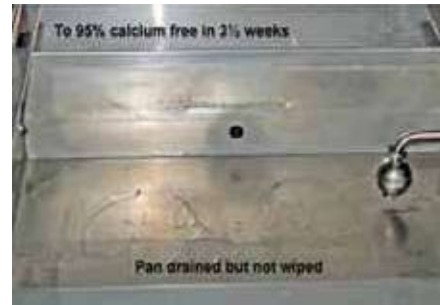
With Vulcan treatment

3,5 weeks after installing Vulcan - May 12, 2011

95% less calcium deposits in the pan

After this very successful using of Vulcan in our White Castle restaurant #49 in Indianapolis, we installed the Vulcan 1000 and Vulcan 5000 device also in the White Castle restaurant #32 in New York and the White Castle restaurant #38 in New Jersey.

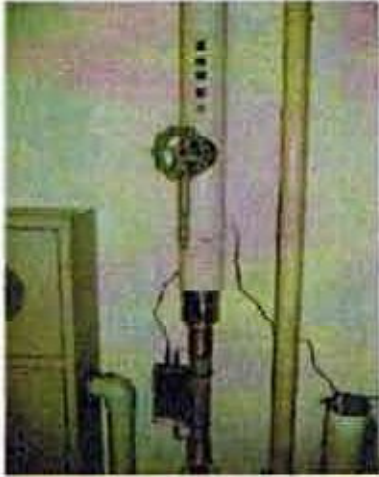
Installation: February 2007
Type: Vulcan 5000

Free-from-trouble structure and easy installation
LED always blinks dependably as it shows processing conditions.

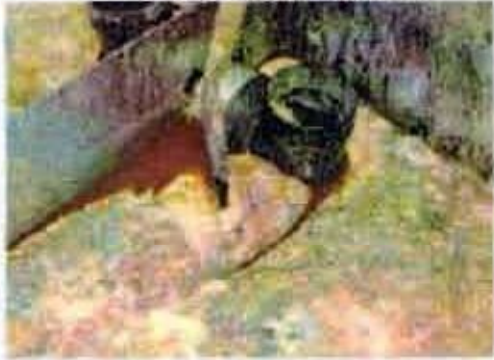
Before Vulcan installation

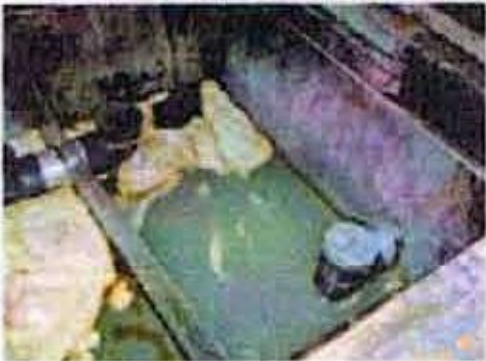
3 months after Vulcan installation

It seems that an effect as the water treatment system appears in view of the result from the last three months, based on only the phenomenon, because the test itself is not a comparison with the last year.

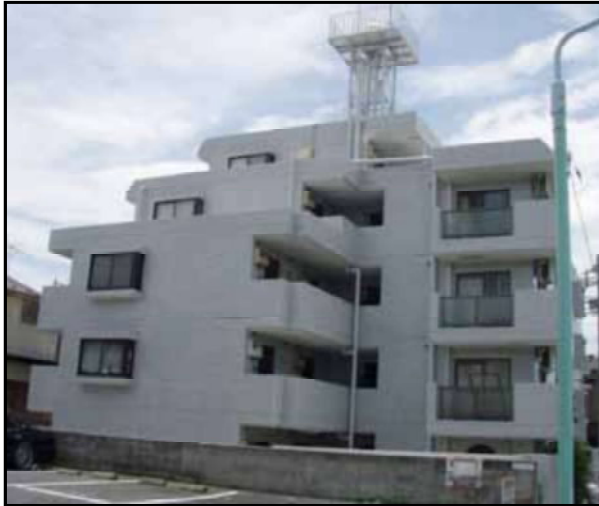
Installation site
: The roof of an apartment building
in Tokyo prefecture.
(an apartment building built 20 years
ago with 46 houses)

Water supply system: Tank at top of roof

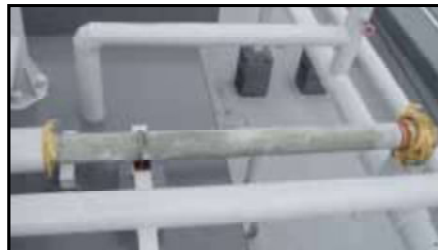
Before installation:
The cover and the lagging material on
the piping are removed for installation.

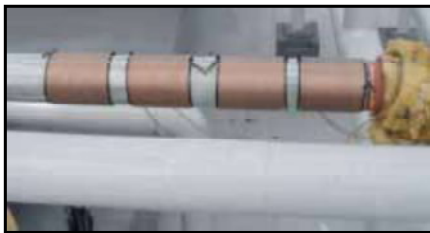
[cable winding completed]

installation to cables and the Vulcan
S25 with in box.

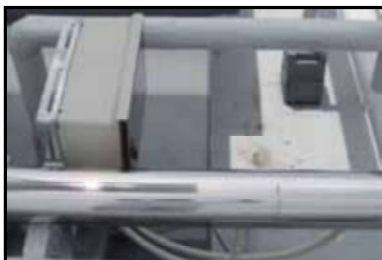
The piping with cable would has been covered with
each new the lagging material and the cover.
Installation for the vulcan completed.

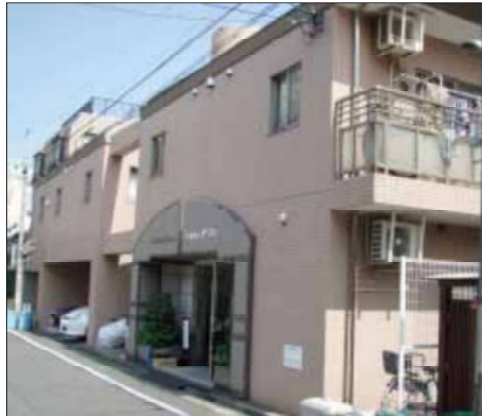
Installation site
: An apartment building in Tokyo prefecture.
(an apartment building built 12 years ago with 23 houses)

Water supply system : Direct & multiply pump system

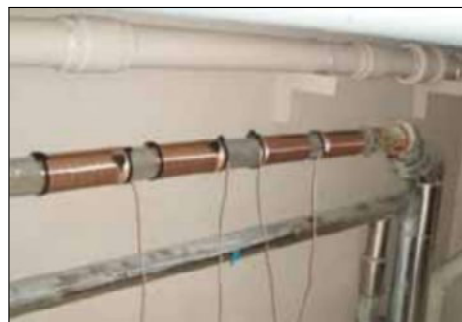
Before installation:
The cover and the lagging material on the piping are removed for installation.

[cable winding completed]

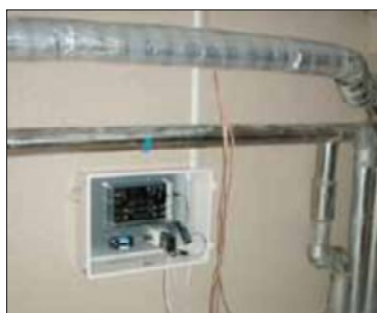
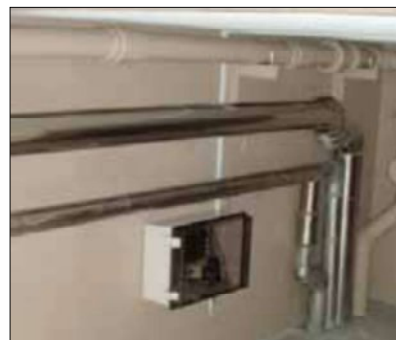
The piping with cable would has been covered with each new the lagging material and the cover.
Installation for the vulcan completed.

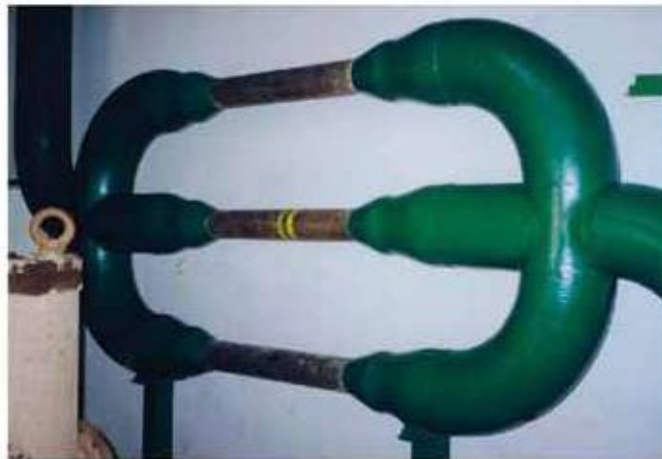
PRESENTATION OF ASSEMBLY AT SŽ-METAL d.o.o. RAVNE

SITUATION BEFORE INSTALLATION – ADJUSTMENT OF TUBE

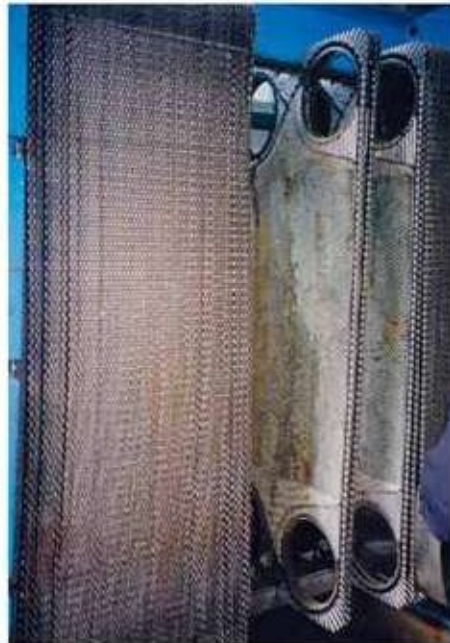
SITUATION AFTER INSTALLATION AND SWITCH-ON

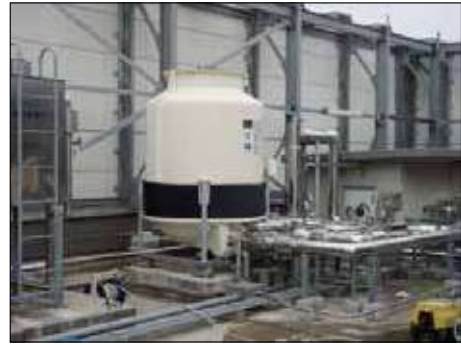
Cooling Tower C

after the hosing
